Critical Firmware Upgrade Nera WorldPro 1000/1010 & T&T Explorer 100/110

This document describes the EXPLORER 100/110 & WorldPro 1000/1010 software release version 2.11.3, and how to upgrade your terminals.

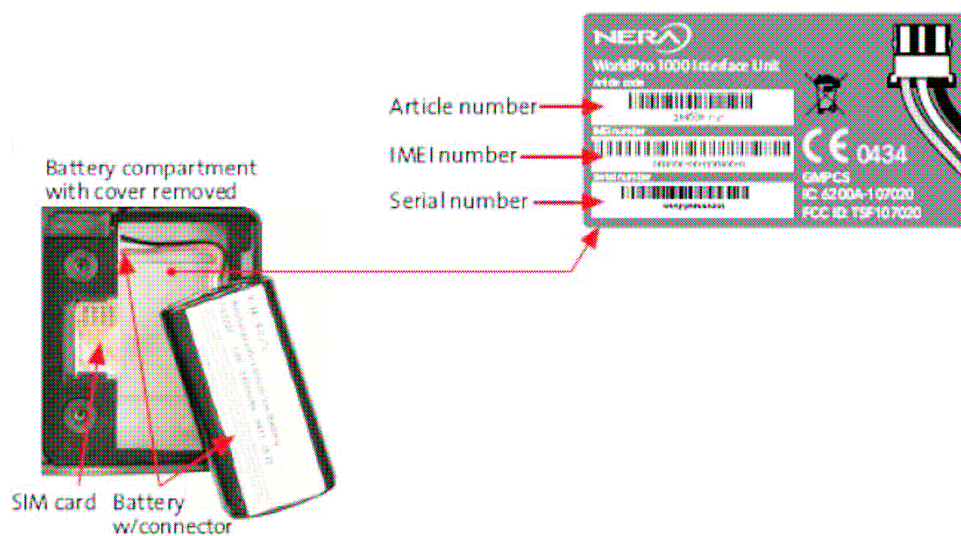
Issue with D-type Beta terminals:

This means that D-type Beta terminals cannot be upgraded with SW 2.11.3 and will NOT be able to connect after the network upgrade.

This only applies to “D-type” interface units (64MByte RAM version=Beta version) produced until August 2005 (Serial number in the range from 0305060000 to 0305089999)

Contact TC Communications, to discuss options for replacement.
